Manhole Inspection Summary

Manhole # S33E__008MH

Insp Date: **8/4/08 12:18 PM**

Location Address: **102 n liberty st**

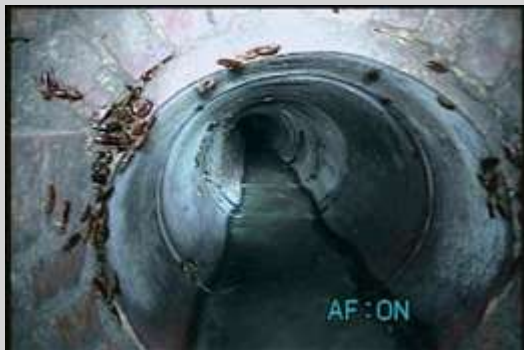
12 O'Clock Outflow

18 in. Circular Gravity Sewer
Pipe Out @ 12 O'Clock

Pipe Material: **Clay** ☐ Pipe Lined

Infiltration: **None** Pipe Seal Cond: **Unknown**
